ANNUAL REPORT FOR 2000

Lengyel Mitigation Site
Craven County
Project No. 8.1170806
TIP No. B-2531WM

Prepared By:
Natural Systems Unit & Roadside Environmental Unit
North Carolina Department of Transportation
December 2000

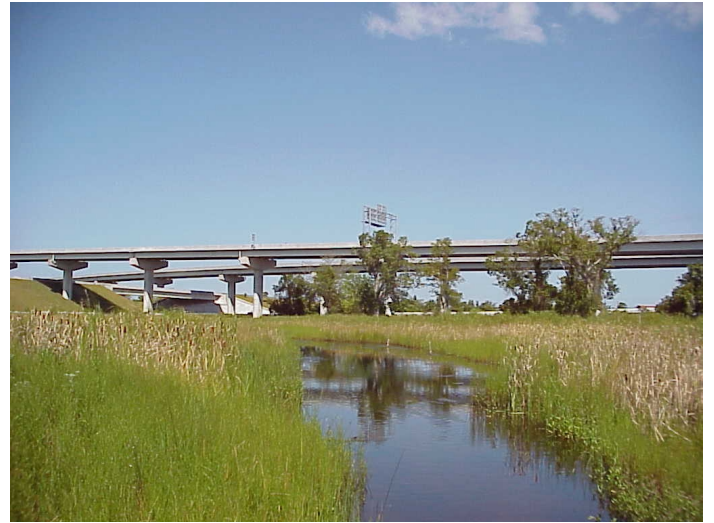
Photo 6: Showing open water channel

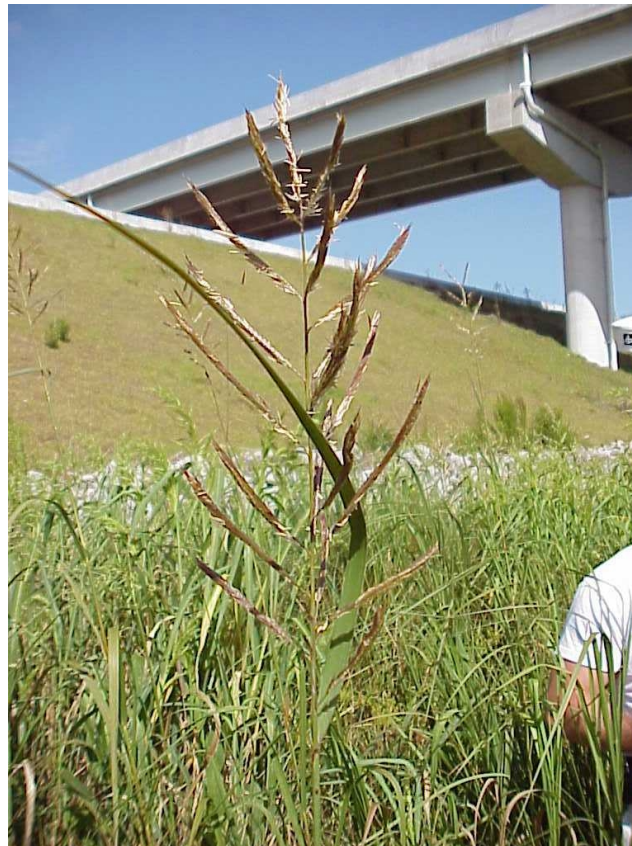
Photo 7: Big Cordgrass
